Progress Report September 2021

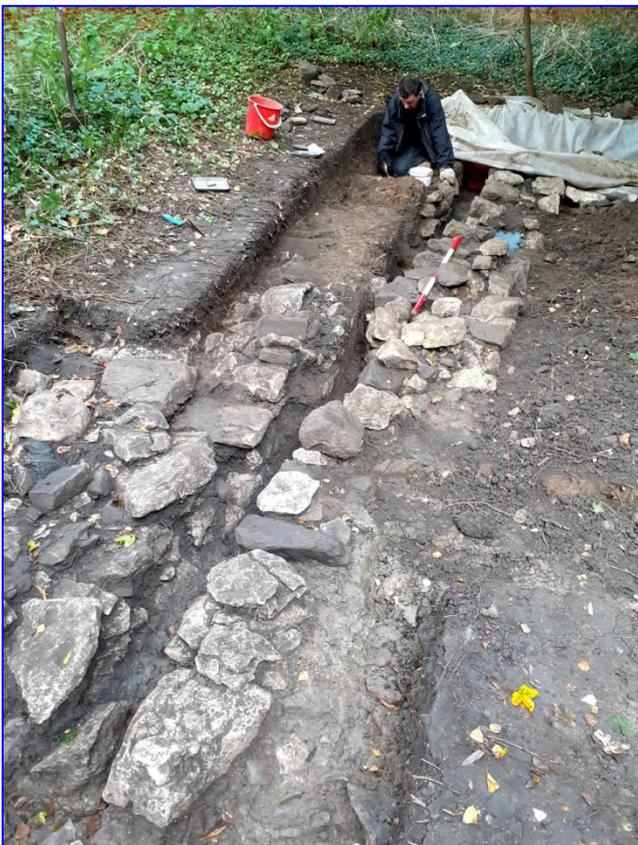
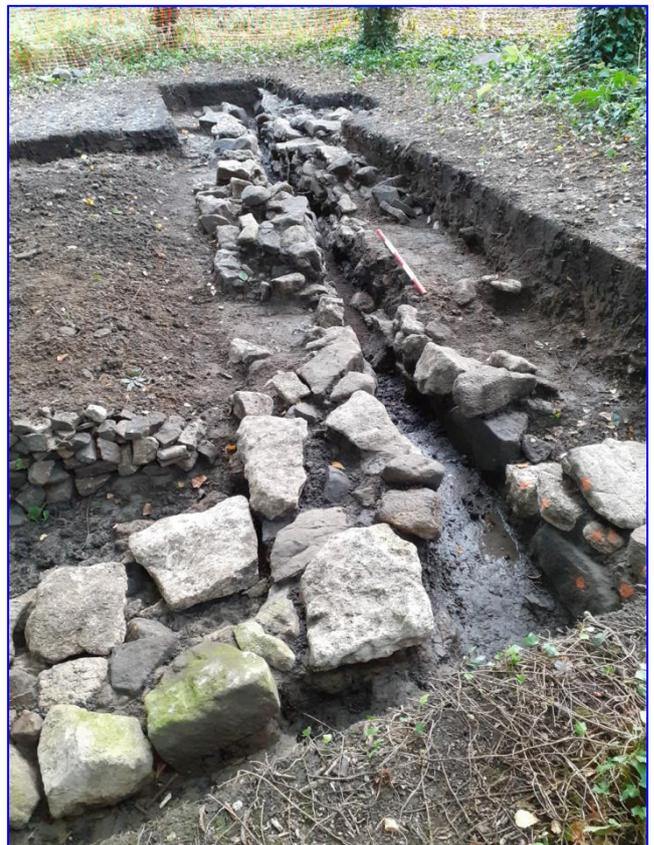
The west wall, respectively looking north and south, showing the channel

5. This brings us to the real surprise about our little building, given its age. It has a water supply. Running down the west side of the building is a stone lined channel and this not only runs into and out of the site (so far) but serves a little covered duct which runs on the inside of the north wall of the building and which turns somewhat before it is cut in the eastward direction by the Victorian sewage pipe mentioned earlier. The operative and extraordinary word there is “inside” .

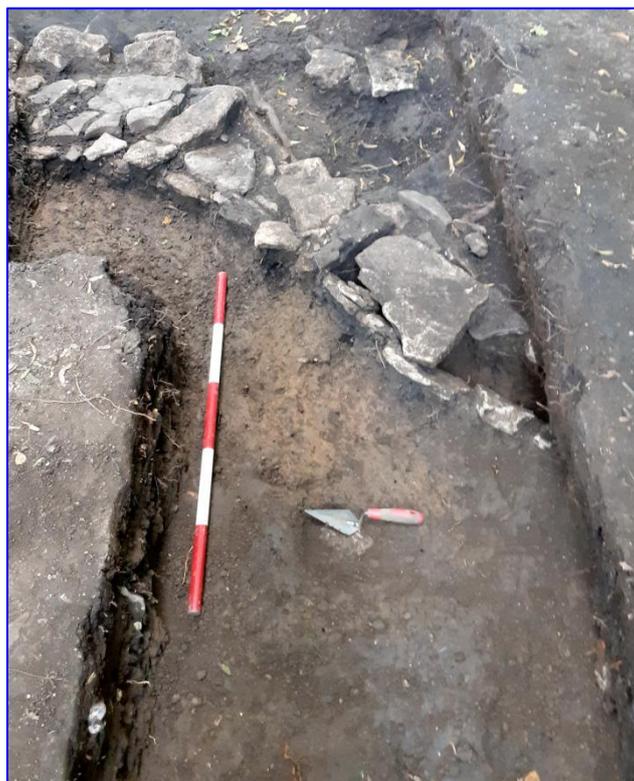
The east end of the water supply duct  
(The metre rod and the trowel are inside the building)
