Section examinations of North Lane on the Chevin between Milford and Farnah Green.

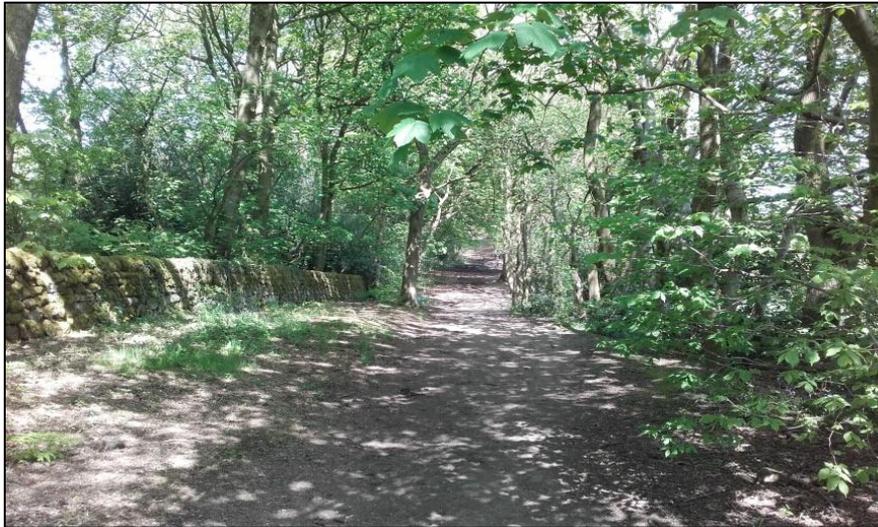
North Lane on the Chevin at Firestone Hill looking towards Farnah Green

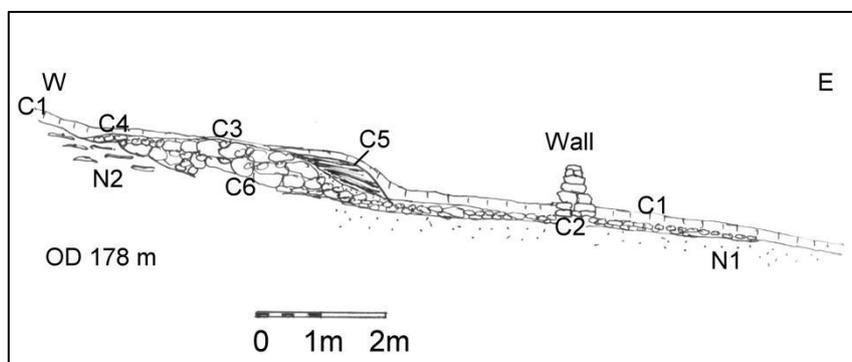
Section 1: Towards the Farnah Green end:

The section diagram for North Lane, Farnah Green.

C1 Turf

C2 Wide loose stoning 10-15 cm gritstones, this appears to be why the road had to be repaired or rebuilt. The spread of stones, assumed to be the first road, appears to have slipped down the hill.

C3 Black, almost ashlike thin hard surfacing, which carries on over the west side agger and also lies beneath C4 and C5, suggests the road was rebuilt and was then in use for a period before the abutment was built to stop it slipping down the hill again.

C4 Narrow (30cm) single layer of smaller stoning which appears to denote the west edge where the natural bedrock rises up to meet it, may represent a kerb at this point.

C5 A layer of very sandy grey striated soil, apparently of cut turf. This appears to form an abutment to hold the stoning in place, which lies on top of C3, so is likely to be the result of a further repair.

C6 The core of the road rebuild, comprised of very large stones (up to 30cm), some of which protrude through C3, but which are worn smooth on their upper (road) surface.

N1 Natural substrate of fawn sandy loam

N2 Natural bedrock of fawn brown gritstone

The two sections of road, although they are constructed on different steepnesses of slope are the same. Both have alike features, that is two phases of road building, a kerb or edge on the west side and an abutment on the other. The only difference is in the material used in the second phase, where at Farnah Green it is fawn gritstone and at Milford it is rammed sand. The edge or kerb on the west side of the road would appear, from the Milford section examination, to be integral to the construction of the second phase road and the abutment on the east side of the second phase would appear, from the Farnah Green section examination, to have been added at a later date to prevent the road agger slipping away down the hill.

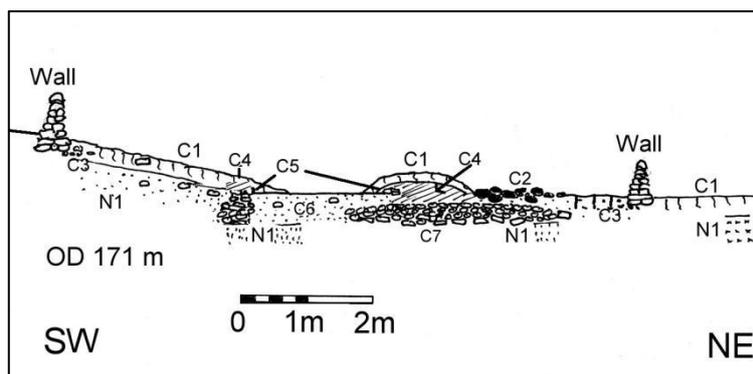
Section 2: Towards the Milford end:

The section diagram for North Lane, Milford.

C1 Turf

C2 Rough very loose stoning 10-15 cm gritstones in black organic fill perhaps tipped as if it were a parish repair.

C3 Understoning of field walls, small stone mixed with soil

C4 A layer of sandy mid grey soil. This is an abutment similar to that in the first examination. There is a slighter version on the upside (south west side) which overlays the kerbing and might represent work to prevent the road getting wet from wash-down on that side. Oddly the abutment at this point appears to overlay the running surface of the second phase road, perhaps due to it having been weathered down over time.

C5 Bedded kerb or edge very pronounced on the south west side.

C6 The road rebuild comprised of rammed reddish fawn gritty sand which appears to be the fill of a trench over 50 cm deep cut into the substrate of N1. This is comparable to context 6 of the first examination, just a different form of aggregate.

C7 The core of the first constructed road, comprised of very large stones (up to 30cm). The base stones of this context are thinner and flatter, and there is some similarity between this context and the bottom of the kerb, which is strangely deep for a kerb and which also has thin flat stones at its base.

N1 Natural substrate of fawn sand with grit and occasional fawn yellow micaceous small gritstone. Note in the field on the north east side, the sand is very red immediately below the turf and soil, which is 30cm deep.

The total width of the whole feature, both roads and their edges, where it hasn't slipped down the hill, is 5 metres 45 cm. The road in the first examination has slipped down the hill so its width is not representative of its original state. In the second examination the running surface of the original road is 2 metres 80 cm and the surface of the rebuilt road is 3 metres including the kerb. In the first examination the running surface of the original road cannot be determined due to slippage, but the rebuild is 3 metres 10 cm including the kerb. The width of the running surface of the road found by Cobbold and Thorpe at Duffield Bank House was 2 metres 90 cm. The Street, at Minninglow, is 2 metres 80 cm on dead level ground.

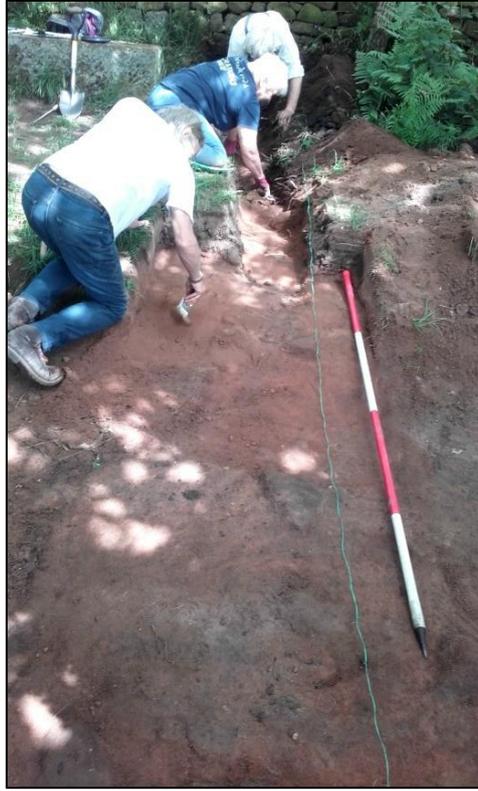
Section trench in progress

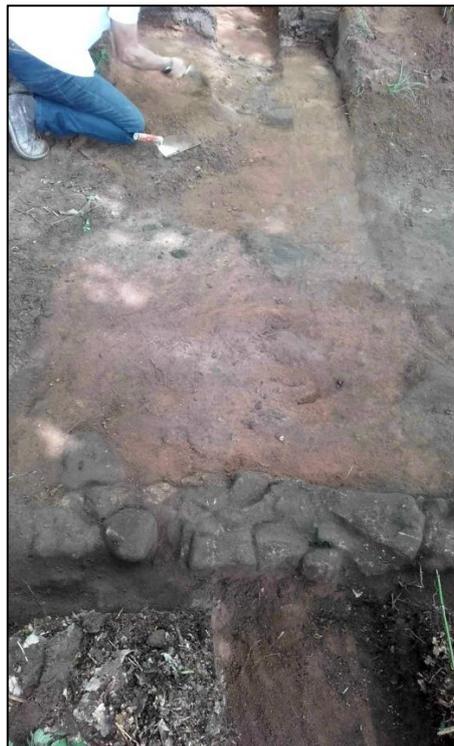
Section trench showing kerb

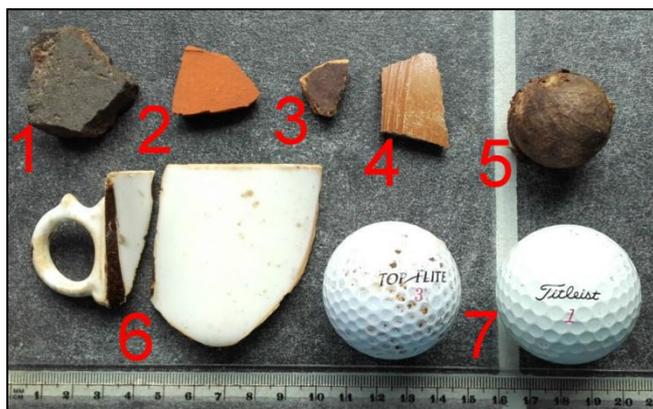
Post-medieval finds from the second section examination (C1 and C3)

- 1. Grey hand made tile shard 2. Shard of plant pot 3. Shard of brown glazed ware 4. Shard of Nottingham Stoneware
- 5. Core of a golf ball 6. Machine made china cup 7. Two golf balls.

Finally we come to finds. In 2012 we had no finds. In 2018 we had various post-medieval finds from the examination and this time we fieldwalked the road from the Milford end to the Rifle Butts and have five shards of Roman pottery from on the surface in different places. Of these, two are from within 50 metres of our examination site and they are both definitive pieces. The first is a rim shard of Roman Derbyshireware, which is identifiable by its shape with those from the Shottle kiln. This kiln operated from the late second century to the early third century, or to speak plainly, perhaps approximately 175 AD to 225 AD. The second shard is a (jar) body shard from the Lumb Brook kiln site. These kilns operated from the mid to late second century to the late third century, or to speak plainly, perhaps approximately 150 AD to 275 AD. As these shards lay on the top of the second running surface this tells us that the earliest date

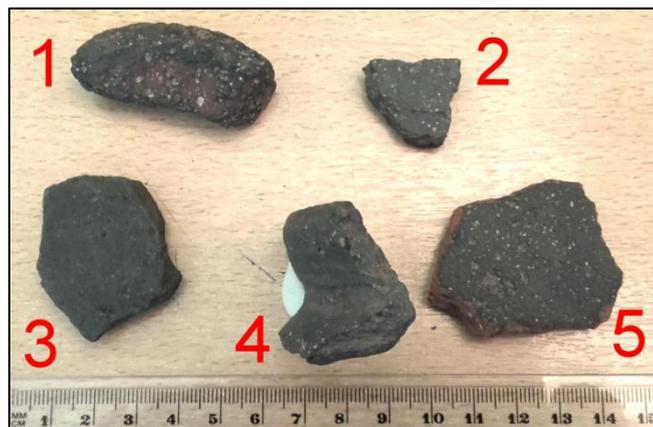
Roman finds from the surface of North Lane

- 1-2 Derbyshireware; 3 Greyware; 4 Rim shard (Shottle); 5 Body shard (Lumb Brook).

at which there could have been a rebuild of this road is perhaps 150 AD. Indeed it might not be working the evidence too hard to consider that the road might have been rebuilt because of the presence of the Roman pottery kilns near here - bad roads between your kilns and your markets equals broken pottery and less income.
