## Wirksworth Archaeological Society

### Progress Report October 2021.

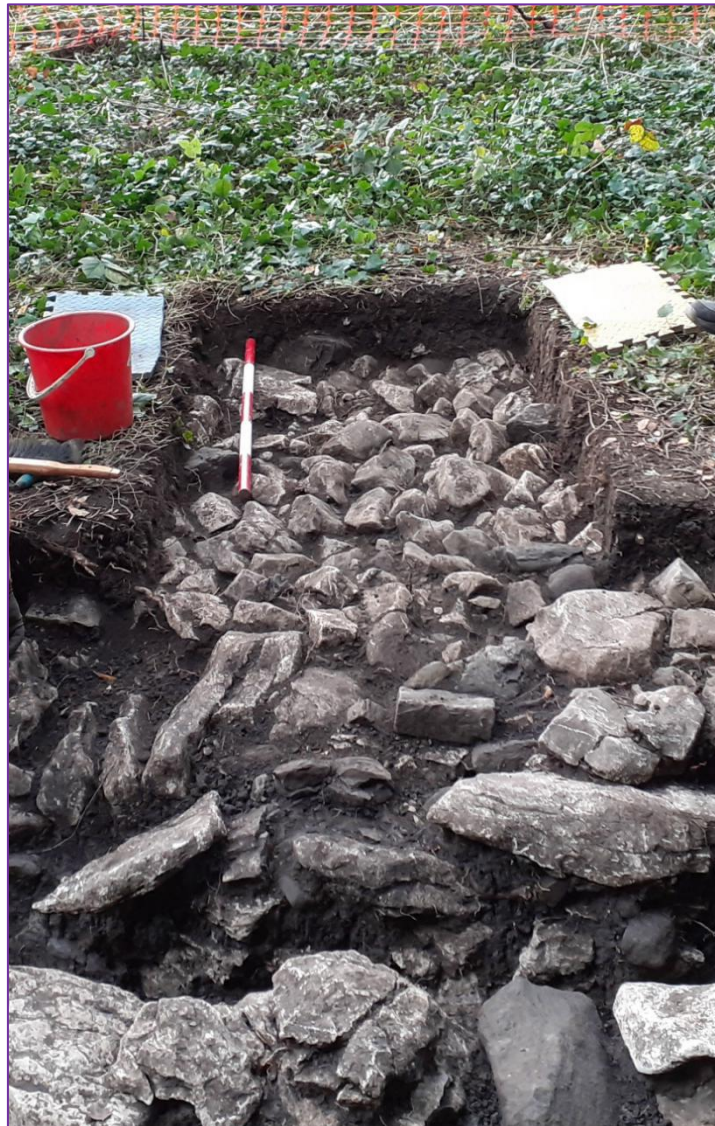
Trench section looking west with stoned surface

In the picture you can see we have added a section off the side of the water channel which runs through the site. The new section is on the opposite side of the channel to the building.

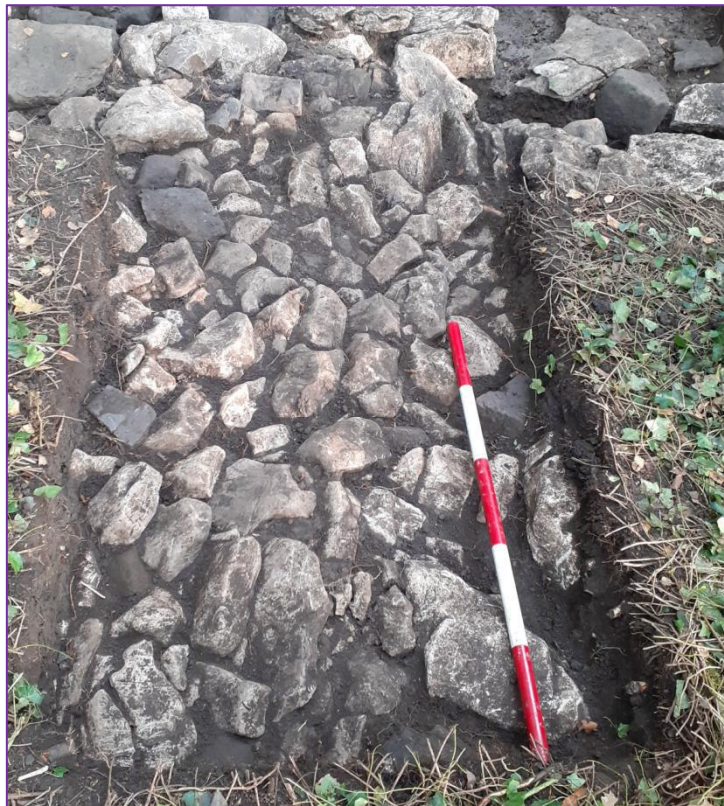
1. Its not random building collapse: its quite coherent and its also fairly level with maybe a slight slope to the south.

2. It might look rough, but the stone which it is composed of is worn, there are no sharp edges, even though the stone lining the channel next to it has quite sharp edges. So this layer must have been more exposed to the weather or some other wearing action such as walking or sweeping.

Yard or path?

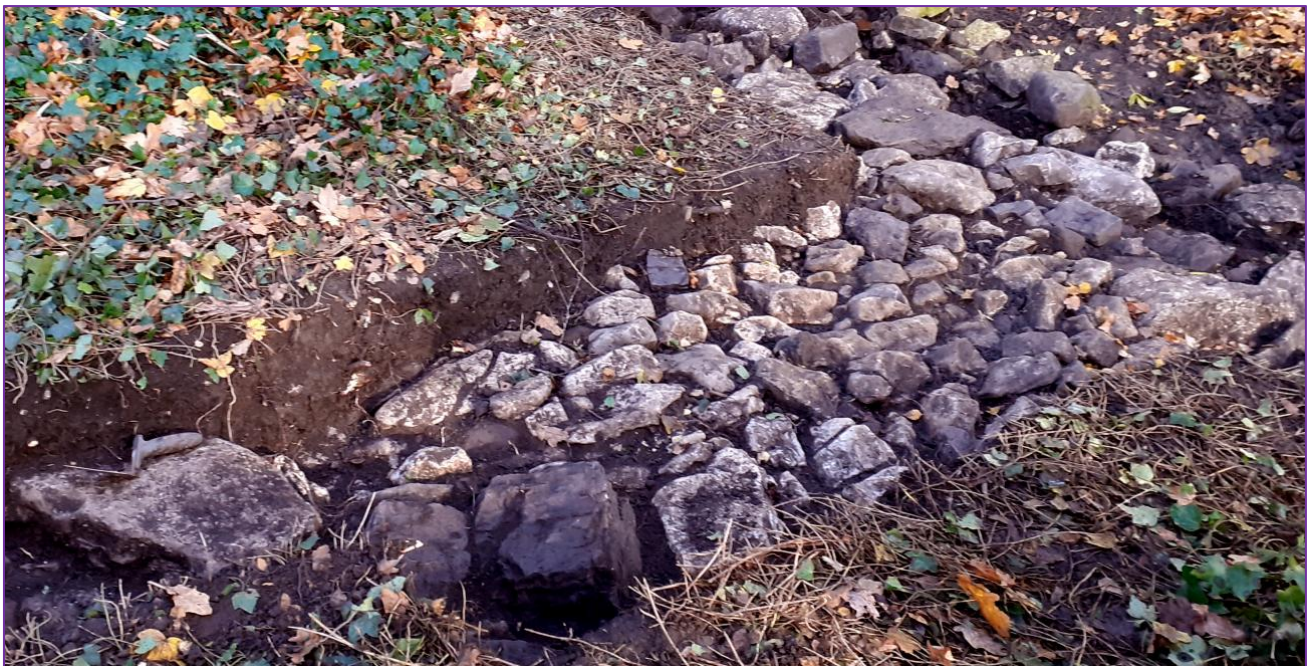
In our final work of the season, on Saturday the 13<sup>th</sup> November, we cleared a little more of the imbricated surface and it appears to have another edge of large stones, this time running diagonally south-east to north-west:

Yard/path? Surface with newly cleared edge of large stones on the left of the picture.

We have not cleared enough of the possible edge yet to know what it is. This will now have to wait for the new season. We have partially backfilled key areas of the site to make it safe over the winter. We have also left the covers off and although this means it will be exposed, people will be able to see it and we will check it on a regular basis to make sure the fence is intact and all is well. We will clear it again when winter is over and the examination begins again. I don't exclude occasional days looking at other features, there are several ditches etc on the aerial photos that could do with a single intervention to check what they are, but I don't propose to do anything more at the Saxon building until the spring.
