Let's start with a quick refresher of where we have got to with our building examination in the Meadows:

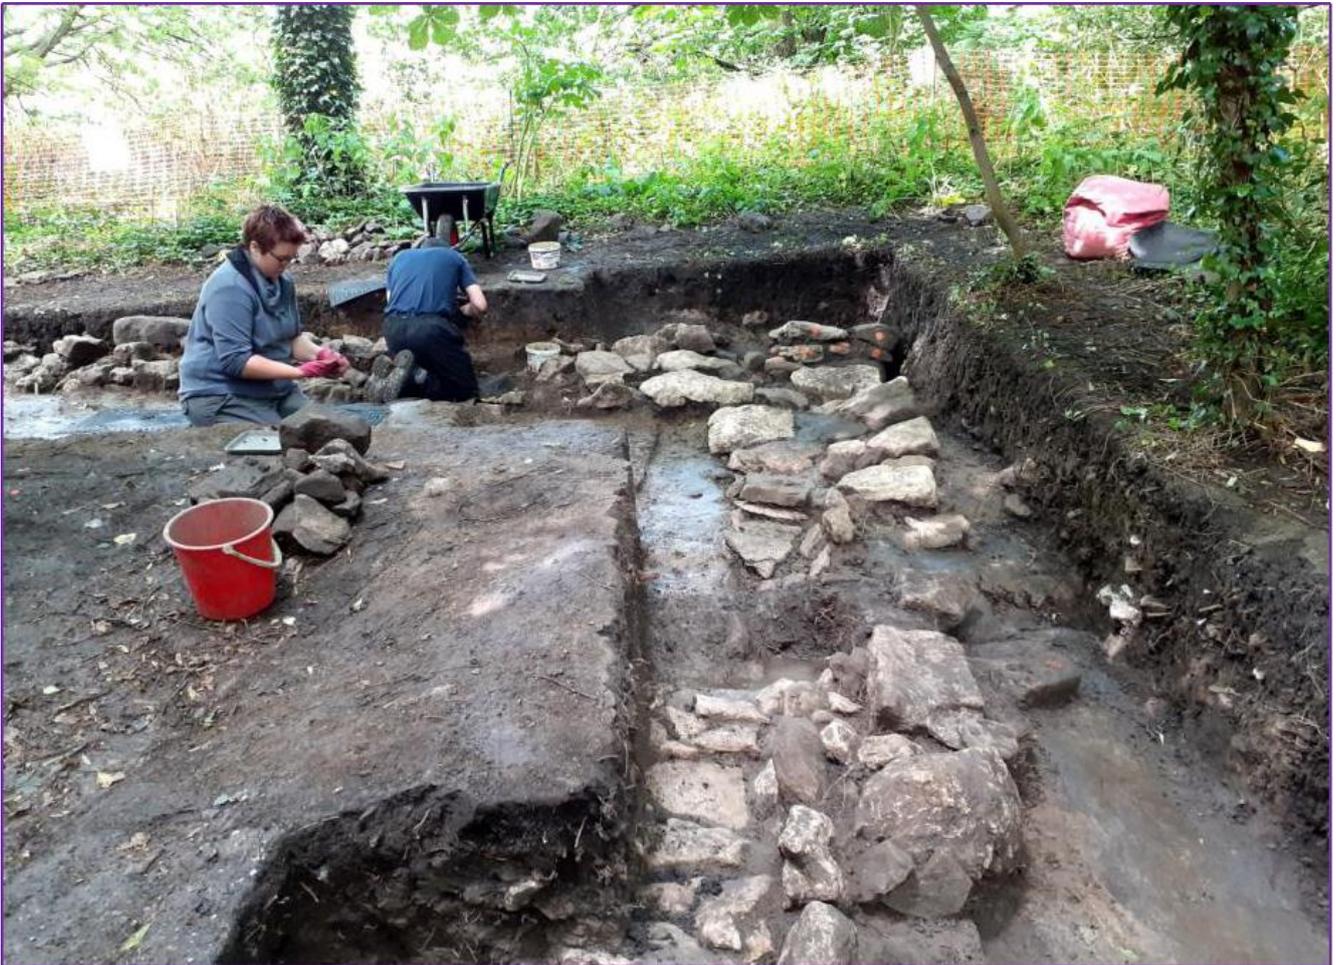
North wall looking west

The dimensions of the building, as evidenced by the surviving north and west walls, is approximately 4 metres by 5 metres. Much of the east side had been dug away by a Victorian sewage pipe. There appeared to be the vestiges of a south wall but these are rather fleeting. Overall, the building would have been about the size of a big modern living room. It has stone walls, judging from the extant remains and spread of fallen material as well as a clay floor, in a clay which has almost got a greenish tinge to it.

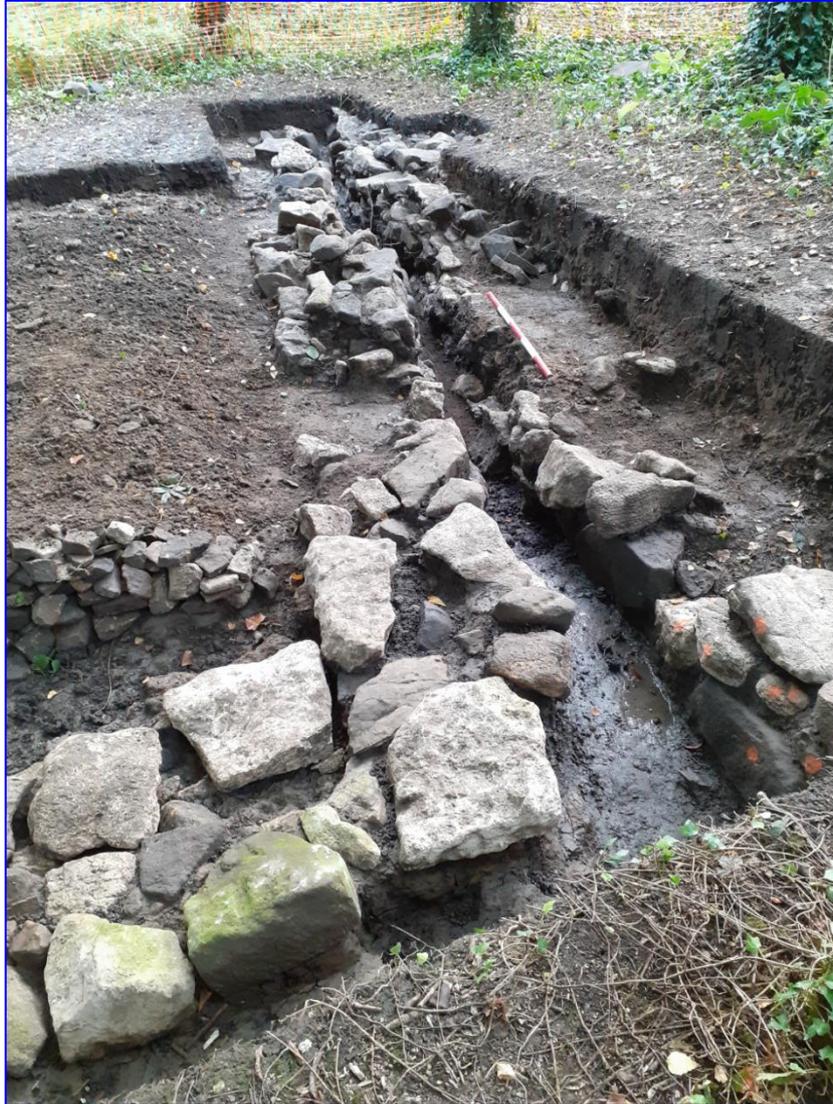
This brings us to the real eye-opener about the building. It has a water supply. Running down the west side of the building is a stone-lined channel that serves a little covered culvert on the inside of the building's north wall. The extraordinary word here is "inside". This is quite astonishing for its time and suggests that the building was not domestic. Indeed, in the late Saxon age most stone buildings were built by the church, even the Lord of Manor would only have had a timber hall, this implies that our building is in some way church-related, although it is not itself a church as far as we can tell so far.

West wall and water channel looking south

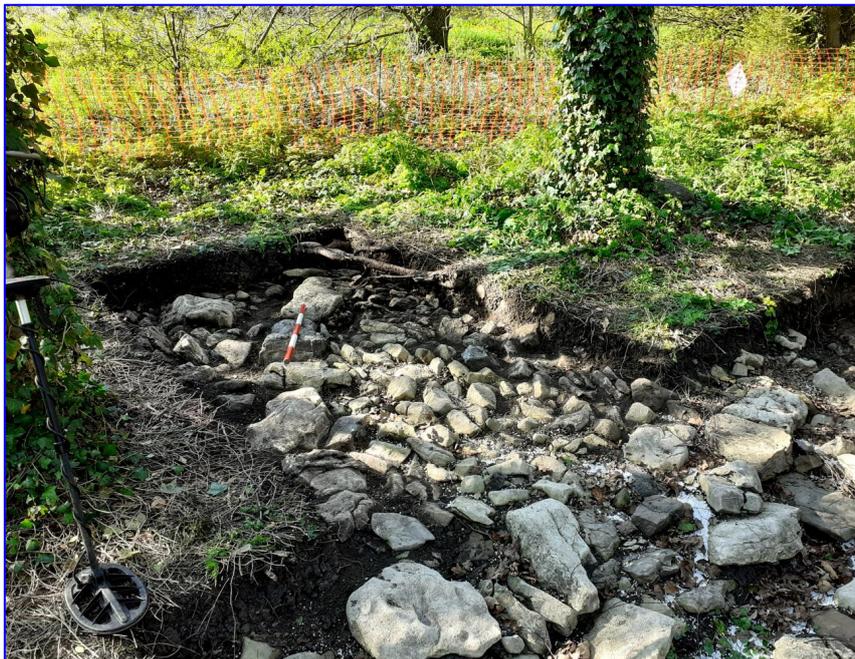
In addition to the building, late in the last dig season we found a laid (imbricated) yard on the west side of the water channel and work early this season in exposing the edges of the yard suggest the yard runs off in a north-westerly direction and we have not yet found its full extent.

Yard looking north west

The work we have done today was to attempt to find the extent of the yard, this is very difficult due to the presence of a number of intertwined heavy tree roots, which we do not wish to disturb, meaning we are having to work in keyholes between the roots. The yard so far does continue in the north west direction under and beyond the tree you can see in the picture above. Hopefully it will end beyond the tree throw, enabling us to complete the picture of how big the yard is and whether it meets anything else.

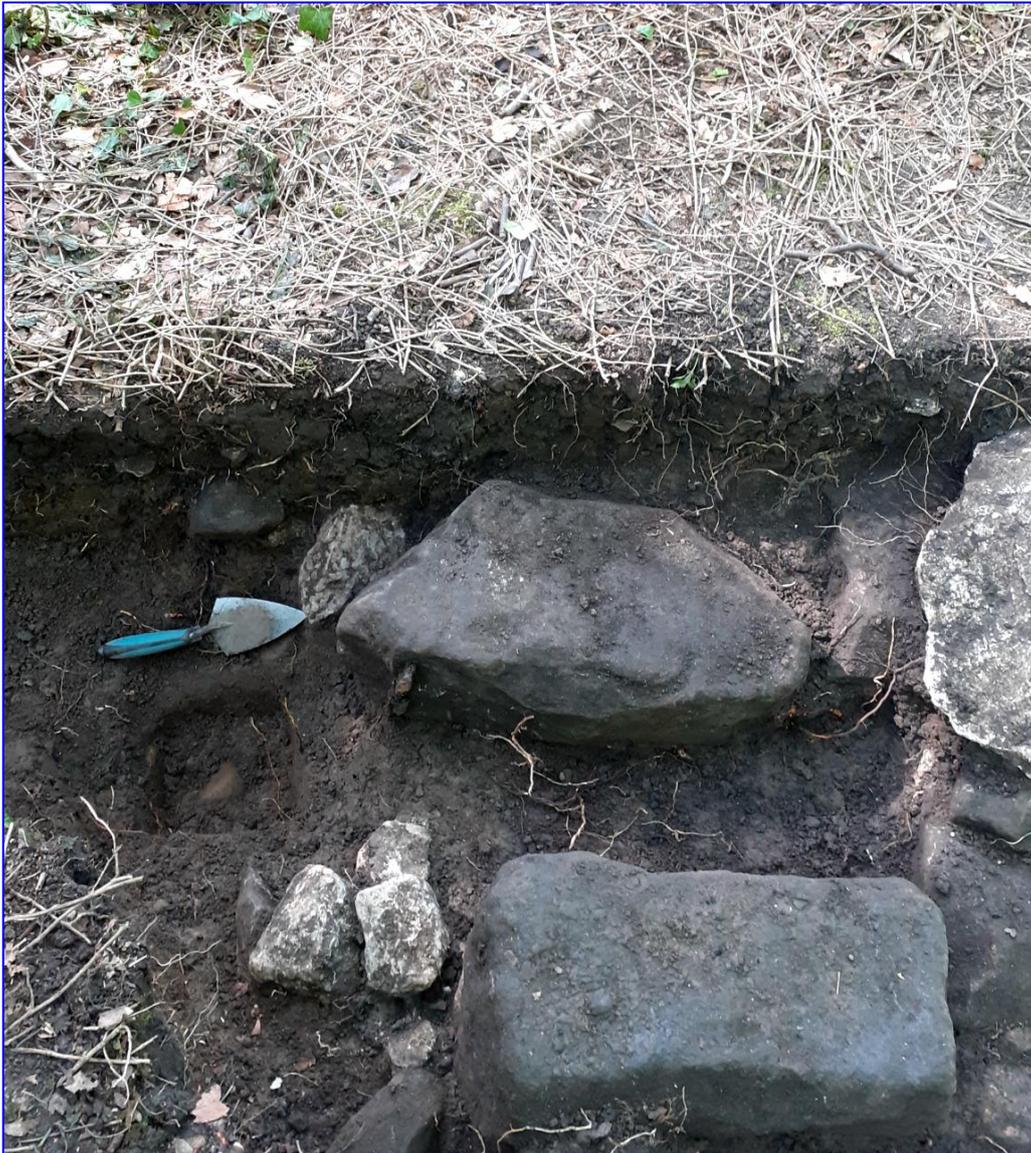
While one part of the team was looking through keyholes, the other part of the team was extending the main dig section southward to try to identify what the water channel did, for example to continue or to turn elsewhere. Within a metre of the point at which we halted last year, the channel lining stops at the two large stones you can see in the picture below.

Water channel revetment stones at the south end of the channel walling

These two stones feel, how can I say, rather definite. They are both huge pieces of dressed stone, they are essentially opposite each other and they are levelled to the same height. In the rest of the channel there are other dressed stones, but they are randomly laid amongst the rough hewn or quarried stone of the channel sides. At the point at which these two stones appear to denote the south end of the built channel, it is not yet clear what happens, but it may be that the lining stops and the channel simply becomes an open leet. In addition, we have remarked on finding re-used dressed stone in this building on previous occasions and in so far as we take the view that our building dates from around the Norman conquest, starting a little earlier, the several re-used heavy dressed stones in it must come from a previous

better-made building or structure nearby that we have not yet found and may not find. We cannot date un-inscribed stones so I cannot say if such a stone-robbled building were Roman, for example.
