Continued examination of the Causeway Ditch

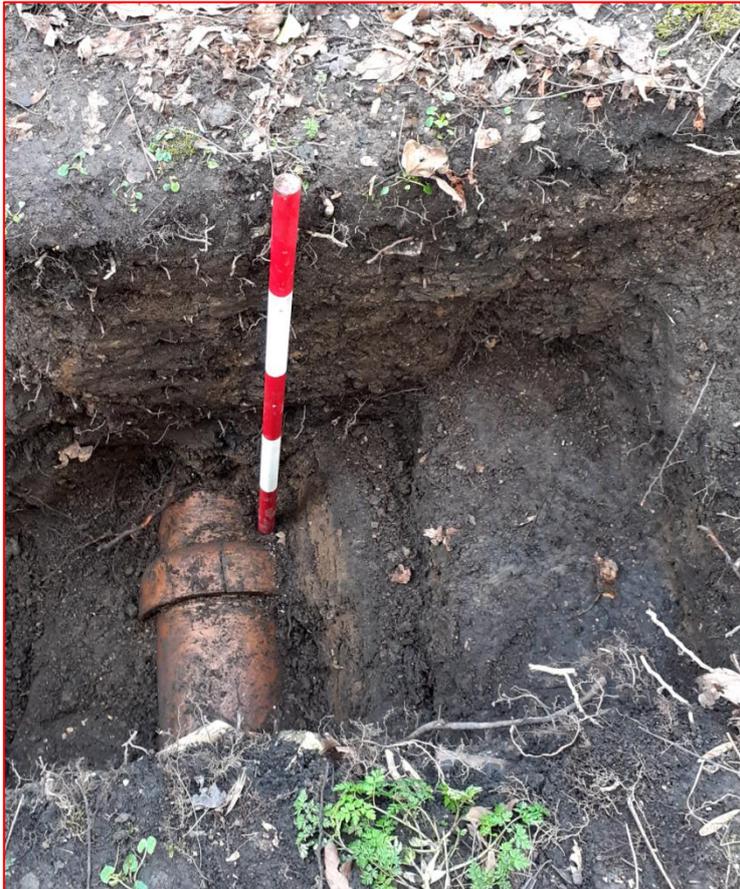
The examination of the Causeway Ditch proceeded on the 27th of February 2021, as outdoor archaeological work is permitted under the current regulations. The work concentrated on the west end of the feature. Buried 1 metre down and 7.20 metres from the boundary wall was a large pipe of salt glazed ware with a 25cm diameter.

The “10 inch” ceramic pipe in the west end of the trench, looking south

This is probably a foul sewer or storm water drain, the cut of the pipe line is V shaped, suggesting it was manually dug (machine cuts are vertical and parallel) but the material over it is redeposited and therefore cannot be dated. The municipal works of the town are somewhat obscure due to lack of historical commentary and assessment of those records which are known.

The pipe would therefore appear to be after 1880. The west end of the trench has so far not been revealing of anything further than is already known from the examination during 2020. One issue, however, has been clarified. The sequence of natural substrates in the west end of the trench is comprised of fawn clay, which gradually becomes a grey clay and then shale. The grey clay seems to be a function of the ditch running with water mixed with organic material which makes the fawn clay a grey colour. We know that part of the ditch was dug out in the medieval age, perhaps in the later thirteenth century and this would have caused a large amount of grey clay to be removed. The upper parts of the fawn clay contain occasional medieval wares but the grey clay contains nothing but small stone and bits of bone. If the ditch was dug out in the thirteenth century then the clay removed might have been used for something and this brings us back to what the Tump is. Had the Tump been constructed from the grey clay extracted from the ditch and a timber building such as a barn built on it (?) then this might account for why we have found next to no obvious archaeological remains there, vestigial timber would be difficult to identify. This might also help explain why there seems to be no ditch-origin grey clay dumped next to the ditch itself, although our examination of the west side is not yet complete. We will return to the Tump at the end of our other work, just in case.
