The Roman Villa at Scow Brook, Carsington by Wirksworth, Derbyshire, England.

**Wirksworth Archaeological Society
10th November 2019**

Anton Shone
Wirksworth Archaeological Society
2019
www.wirksworthromanproject.co.uk

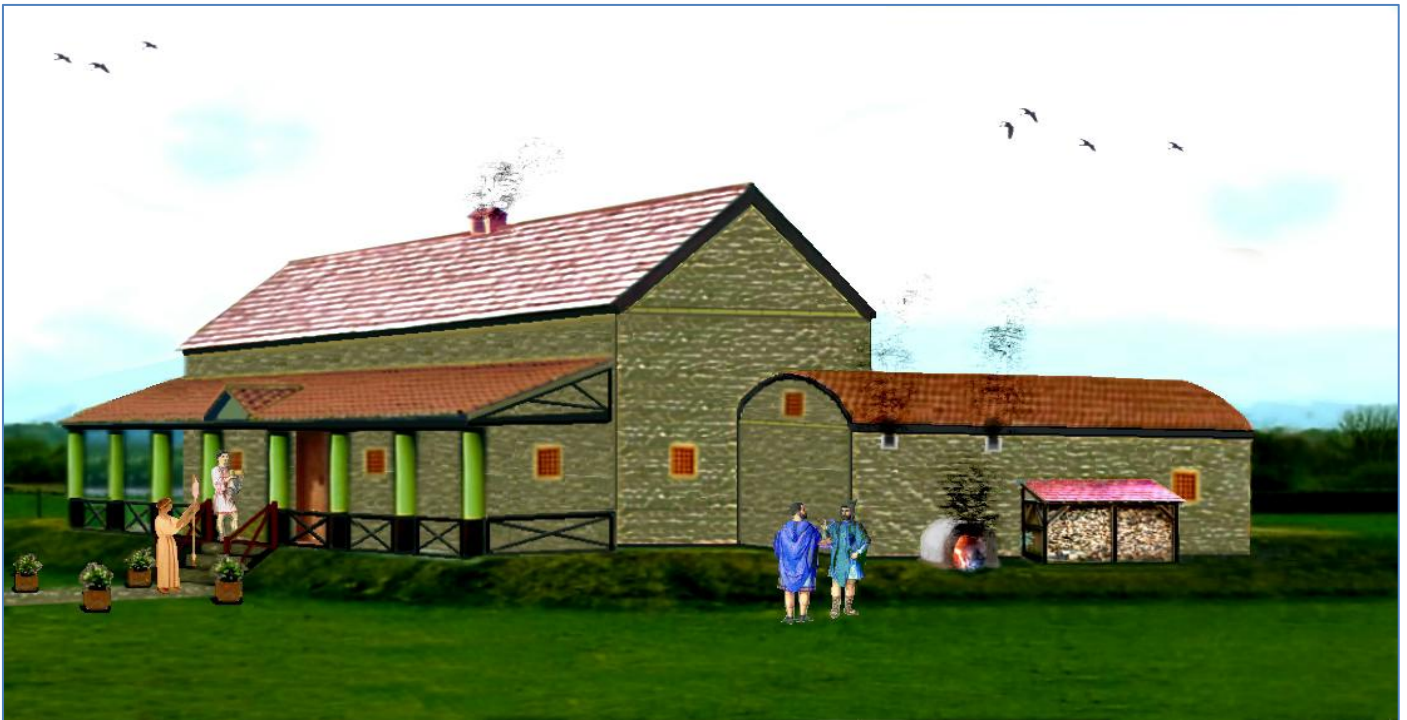
Artist's impression of how the villa might perhaps have looked

The villa was constructed of sandstone and grit stone, and the sandstone may have been quarried nearby at Warrington Knob, where there was a small disused quarry reported by the archaeologists. Grit stone (Millstone grit) could have been obtained from the south side of Pitty Wood which is about 1.5 km south west of Wirksworth. This would give it the appearance of a large stone-built Derbyshire barn or farmhouse but with crucial differences: the villa had a verandah on its main west frontage; It had small Roman windows (window glass was found in the excavations) with shutters; the main house had a pink shiny stone slate roof and this was composed of mica sandstone from a quarry at Wyver Wood at Belper Lane End (Palfreyman and Ebbins, 2015): this would have glittered in the sunlight; the bathhouse and the verandah had pantile roofs composed of Roman imbrex (curved) tiles and tegula (flat) undertiles, which were orange. In short it would have stood out clearly in the background green of the landscape.

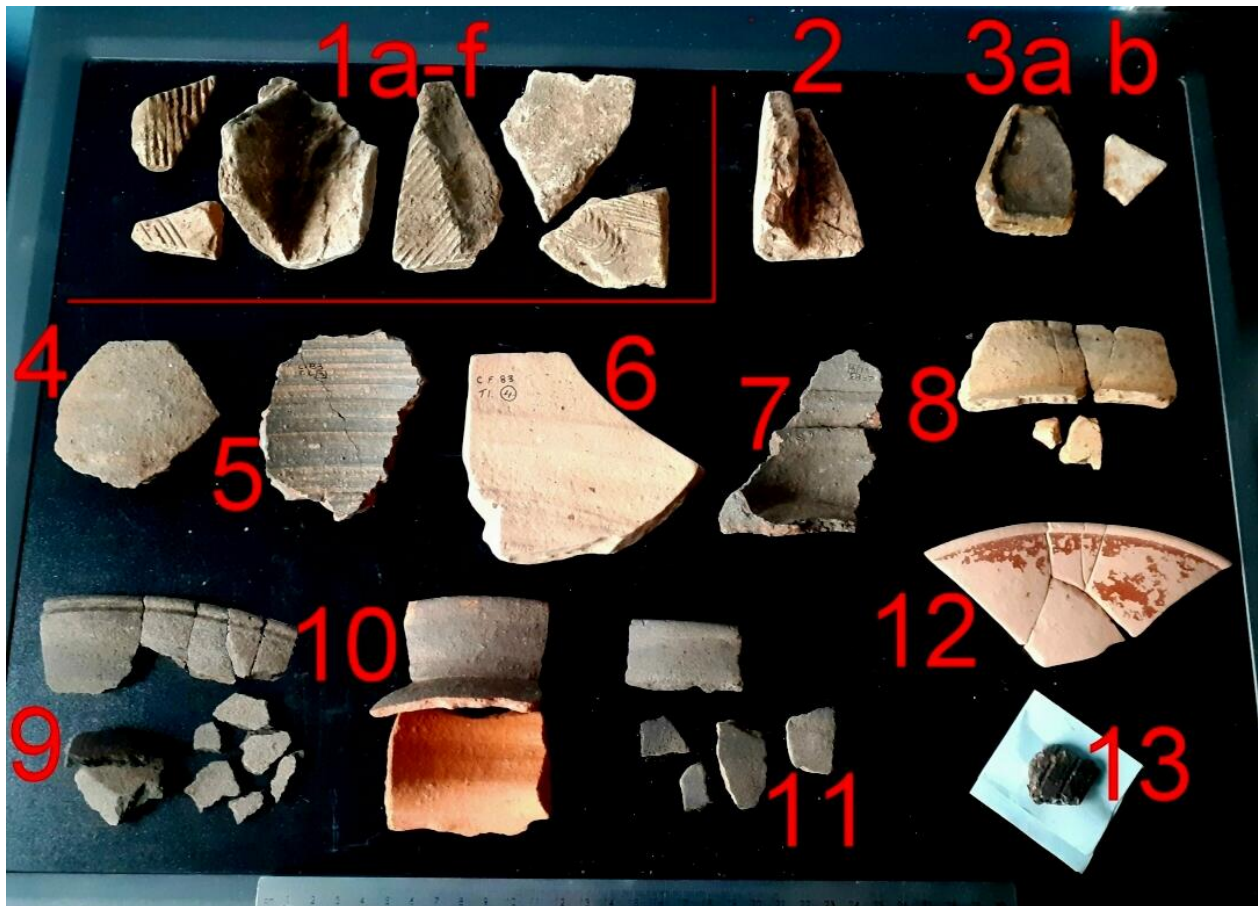
Numbered image of the pottery

Items in the above photograph and some related bag numbers.

1 a-f. Six sherds of Coarse Buff Ware box flue tile (tubuli). Not listed with a bag number, but see Ling and Courtney, (1981) for the fabric types. Total weight 267 grams.

2. One sherd of Coarse Red Ware flue tile. Not listed with a bag number. 99 grams.

3 a b. Two pieces of shaped stone. 3a has a blackened interior coating as if it were used as part of a mould for something, but had it been a pottery item it might have been interpreted as the base of a small oil lamp. 3b is of no identifiable function. Neither have any annotation. Unweighed.

4. Number on item: Bag number C.F.83 T.1. [4] Orange-grey hard fabric body sherd of Derbyshire ware 61 grams.

5. Number: C.F.83 T.1. [3] Very hard grey fabric orange core, striped effect interior surface, body sherd in two parts 67 grams
6. Number: C.F.83 T.1. [4] Very smooth unknown pink thick fabric tile? with pale grey core and red spotted inclusions 171 grams

7. Number: C.F.83 T.1. [4] Derbyshire ware base sherd, grey outside, thin layer of orange and black core in two parts 96 grams
8. Number: C.F.83 T.1. [4] 27. Derbyshire ware rim sherd buff orange, light grey core in six parts, two glued together 68 grams

9. Number: C.F.83 T.1. [4] Grey ware rim sherd with black core in thirteen parts 56 grams
10. Number: C.F.83 T.1. [4] 12. Rim shard of large open neck jar, gritty red-orange fabric grey colour coat in two parts 120 grams

11. Number: C.F.83 S.1. [4] Five sherds of grey ware of possibly different vessels, largest being a rim sherd of 17 grams
12. Number: C.F.83 T.1. [4] 19. Rim sherd of Samian ware (or copy of Samian) in five parts, broken as received but this is item ix listed on page 40 of Ling et al, 1990. It is the only rim sherd of Samian recorded. Considered to be Central or East Gaulish Samian possibly of Antonine date AD138-193 and perhaps a "Colchester" copy. 36 grams very soft and very worn.

13. No annotation. Single sherd of rouletted black burnished ware 5 grams.
